TECHNICAL WARNING ISSUED BY LESTER CONTROL SYSEMS LIMITED issued 28-08-2018.

INSTRUCTION GUIDE TO REPLACING AN ALMEGA 2 SERIAL I/O CARD.

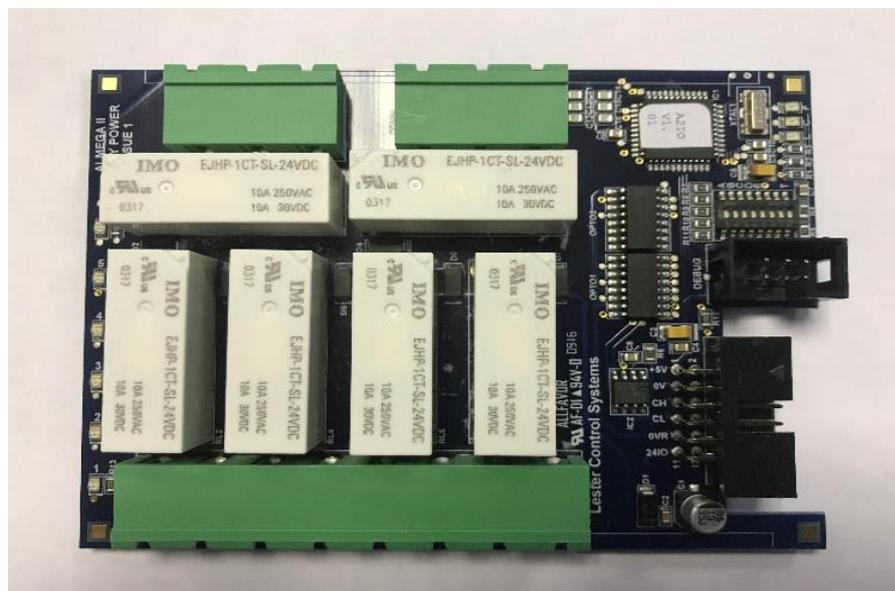
As shown in photo below, the new slot card will have A2 IO V1.01 software version on the white I/D label.

If the controller does have this issue, Lester controls will send a replacement slot card which solves the issue with a pre-paid envelope to return the replaced card and full slot replacement instructions.
